Preliminary Examination of a Premature Failure in a Cold-Working Die for Sheet-Metal Cutting

ABSTRACT

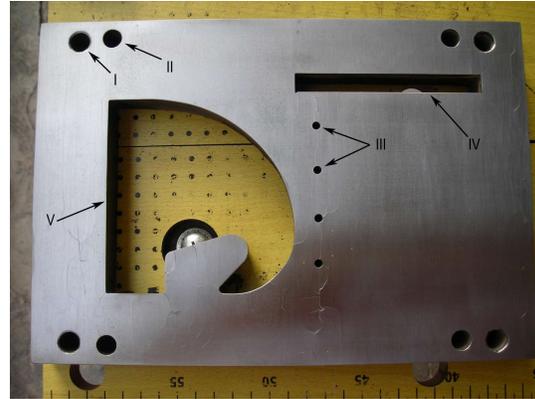
Figure 1 shows a general aspect of the die face. At each corner, there is a pair of holes, designed for the assembly via toggles. The diameter of the four external holes is 10mm (point I in Fig.1). The internal holes have a diameter of 9.5mm ending with a flash-off (point II in Fig.1). At the centre of the die, there are four openings 3.65mm in diameter. These openings end up to a vent (point III in Fig. 1) and were designed for cutting. A rectangular gap is observed on the upper right side of the die, with dimensions of 88.3mmx9.8mm, which was intended for cutting (point IV in Fig. 1). On the left of the cutting edges, the main G-shaped cutting section is located (point V in Fig. 1).

Fig. 1. General aspect of the die face

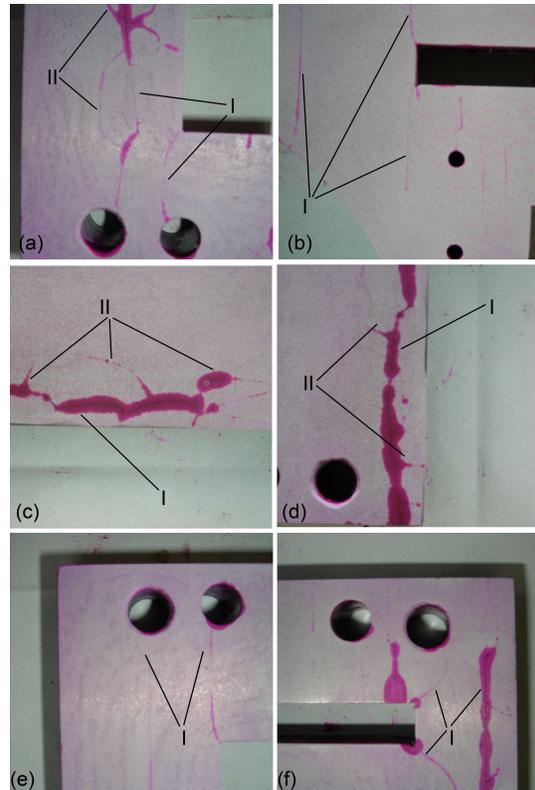
The surface that failed (die face) during final grinding presents a network of primary and secondary cracks. Inspection using penetrating liquids revealed the main cracks on the surface of the die (point I in Fig. 2), and the largest secondary cracks (point II in Fig. 2). The main cracks are gathered around the holes, the cutting gaps, the points with narrow radii and the edges of the die. All the wide cracks begin from the vents.

Fig. 2. Inspection using penetrating liquids. Parts of the die (a) lower left corner, (b) inner side of cutting area, (c) internal of the complex cutting gap, (d) lower right side, (e) upper left corner, (f) upper right corner

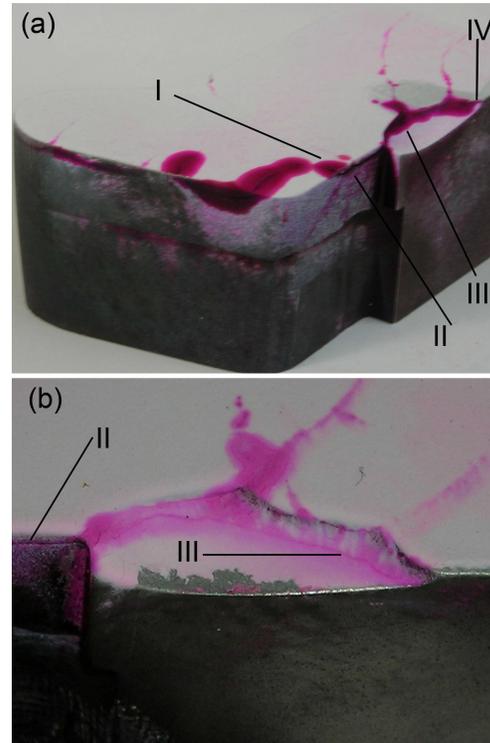
The crack initiation is more intense at points where the distance between vents is narrow. The development of secondary cracks occurs to an angle in relation to the main cracks. Inside the complex cutting profile, a subsurface crack initiates from a flash-off (point I in Fig.3a), propagates to the centre of the die passing through the radius (point II in Fig.3a,b), progresses as a loop (point III in Fig.3a,b), and ends up to another vent point (point IV in Fig.3a). At this point, the crack caused the material detachment.

Fig. 3. Fragments of the die from the interior of the complex cutting area, after inspection using penetrating liquids

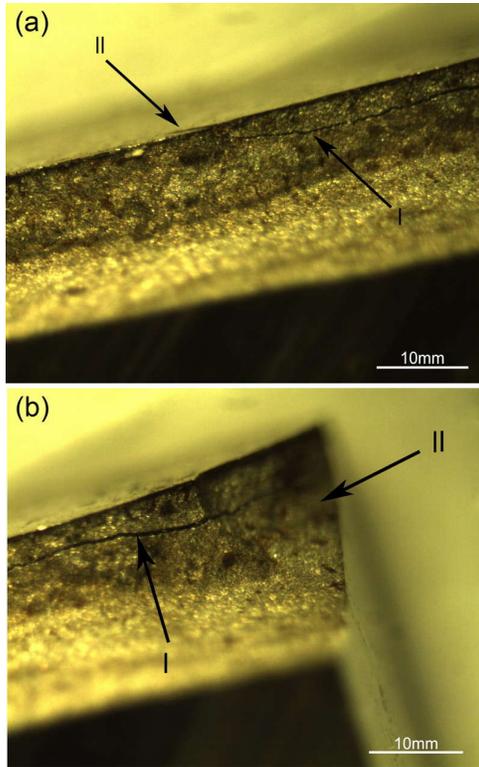
The area where the crack caused the material detachment was examined using a stereoscope (Fig. 4). A network of subsurface cracks is observed (point I in Fig. 4 a, b), which began from the surface of the ‘face’ near a vent (point II in Fig.4 a). The crack was located about 2mm under the surface, and caused the material detachment at a point with a change of radius (point II in Fig. 4 b).

Fig. 4. Area of the subsurface crack that caused material detachment (examined with stereoscope)

Detachment occurred on a concave surface, since the complex geometry caused the development of diverse stresses in the specific area. As expected, the fracture surface is brittle, without showing any signs of previous plastic deformation, since the crack propagation is an extremely vigorous process.
